September 13, 2017

**Re: Residential Asbestos Building Inspection Report
307 North Front Street in Dowagiac, Michigan
Heartland Project #5303-17-01**

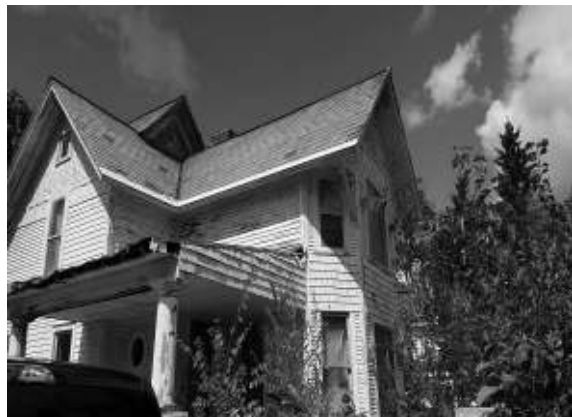
Photo #1:	View of exterior of house (September 5, 2017)
-----------	---

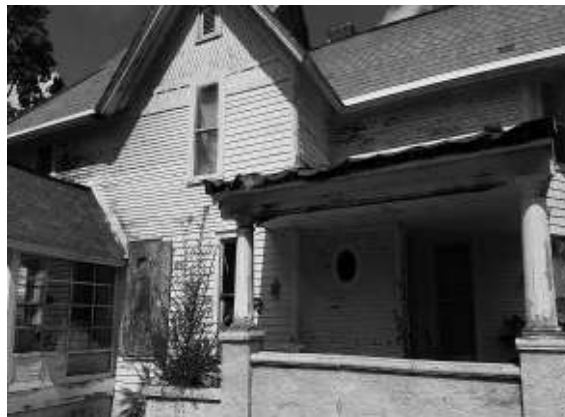
Photo #2:	View of exterior of house (September 5, 2017)
-----------	---

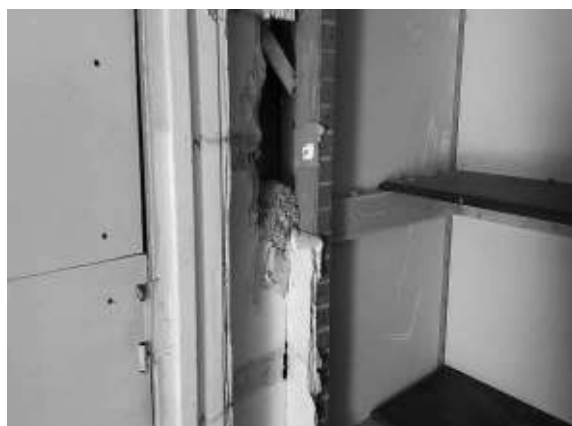
Photo #3:	View of plaster and insulation in interior of the house (September 5, 2017)
-----------	---

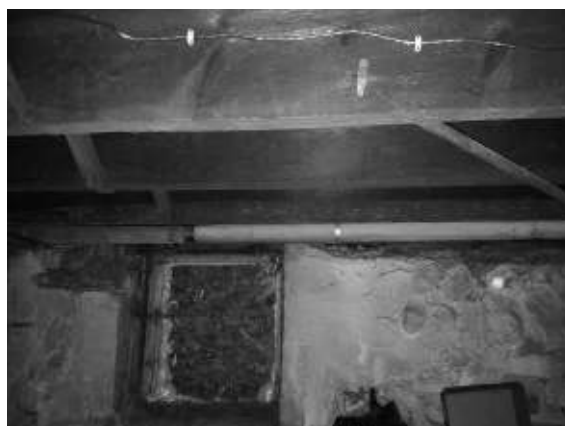
Based on the results of this asbestos building inspection, ACM was encountered in the form of TSI pipe wrap and associated mudded joints located on select horizontal and vertical piping in the basement. The TSI pipe wrap material is a friable material and is considered RACM.

Photo #4:	View of TSI pipe wrap on horizontal pipe chase in basement (September 5, 2017)
-----------	--

It is the understanding of Heartland that the dwelling will either be renovated or demolished, meeting the definition of renovation and demolition, in accordance with the National Emission Standards for Hazardous Air Pollutant (NESHAP) for the State of Michigan. RACM (TSI pipe wrap and joints) was identified in quantities less than the written notification requirements (>260 square feet) specified per Michigan Department of Environmental Quality (MDEQ) Air Quality Division NESHAP 40 CFR Part 61, Subpart M and per the Michigan Department of Licensing and Regulatory Affairs (LARA) Asbestos Program P.A 135 of 1986, as amended, Section 220. Written notification to the MDEQ/LARA at least ten (10) working days prior to any future planned renovation/demolition activities will not be required. Heartland recommends abatement of these materials be conducted by licensed asbestos abatement workers accredited in the State of Michigan prior to any future planned renovation and/or demolition of the building.

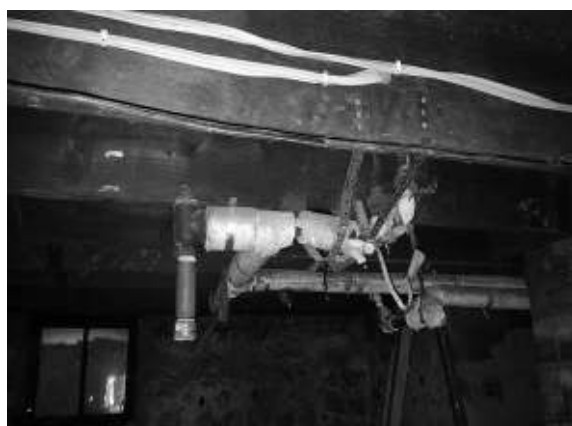
Photo #5:	View of TSI pipe wrap on horizontal pipe chase in basement (September 5, 2017)
-----------	--

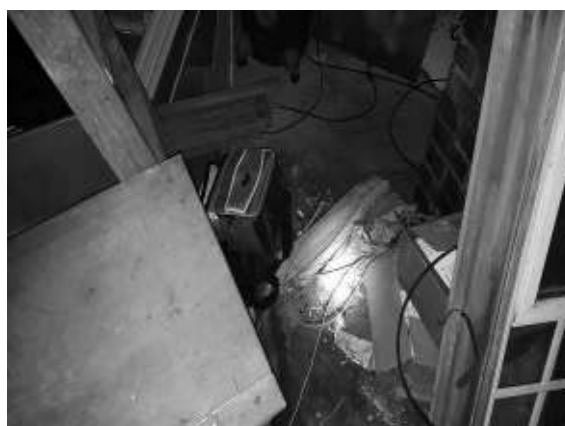
Please note TSI pipe wrap was also observed in damaged condition on the floor of the basement. Care should be taken to limit access and exposure to this damaged RACM materials until proper abatement of the material can take place.

Photo #6:	View of damaged TSI pipe wrap on floor in basement (September 5, 2017)
-----------	--
