# **KELLER ENGINEERING, INC.**

June 8, 2009

**RE: 1899 CASS COUNTY COURTHOUSE  
ENGINEER'S PROJECT #0906-102**

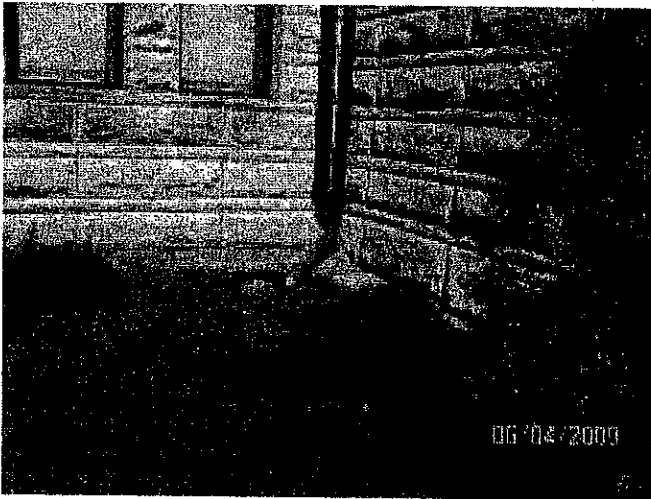
Since the building is situated on top of a hill, all of the water affecting its foundations comes from the roof and lawn areas on the property. We noted areas where the ground against the building is flat, or slopes toward the building. Also, many of the downspouts are piped into the ground where apparently they discharge water near the building.

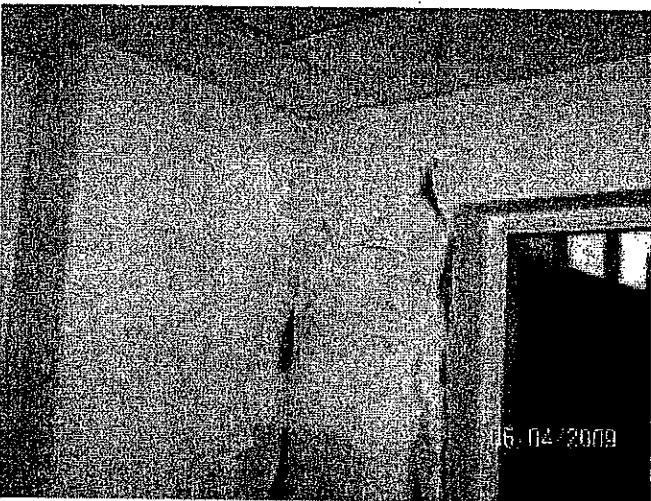
Many of the downspouts are also damaged from ice, which has split their seams allowing water to flow down the face of the building. The plaster inside the building near these leaking downspouts is damaged higher on the walls indicating that water is soaking into the walls from these damaged downspouts. We recommend that the gutters and downspouts be repaired and that the underground drainage system should be redone to get the water away from the building. From a building preservation stand point, it would be preferable if the roof drainage system could discharge to the east where it will flow away from the building to the

city's storm drainage system. A buried drain system could be installed around the perimeter of the building when the ground is put back following the tuck point and waterproofing operations along the west and south walls.

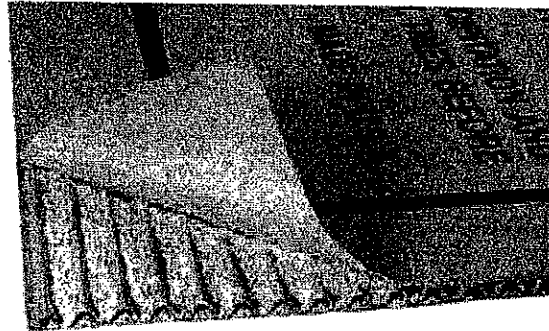
Both the Kingscott report and the Slatile proposal recommend installing bentonite waterproofing on the outside of the foundation walls. We concur with this recommendation. This is an excellent product for waterproofing basement walls; however, since the walls are built from stone, they are very rough and uneven. Although the bentonite will conform to the shape of the wall, we recommend that the walls should be tuck pointed on both the inside and outside to restore their strength, and to reduce the uneven exterior surface for the bentonite. This product comes in the form of cardboard panels with the bentonite in the cores of the cardboard. As the ground is backfilled over the product, it could compress and tear the cardboard unless the surface is relatively smooth. Therefore, in our opinion, the tuck pointing will help prepare the surface of the wall for the bentonite.

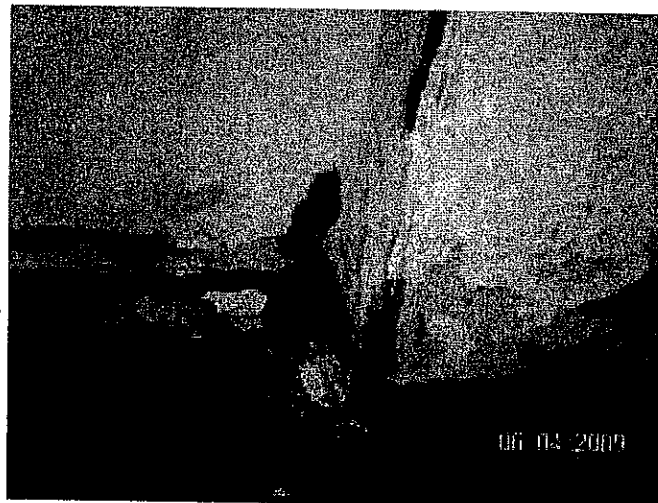
We concur with the Kingscott report regarding their intention to prevent water from penetrating into the masonry because of the permeable nature of the stone and mortar. If the masonry is moist, it becomes susceptible to freeze/thaw during the winter. Moist masonry walls also increase the humidity within the building, which damages finishes and promotes the growth of mold. The high humidity in the building also results in the deterioration of the plaster and lath, which regularly fall

from the ceilings and walls.

Therefore, if points of water intrusion can be identified in either the roof or the walls, they should be corrected. The Kingscott report indicated that the roofing shingles are more than 30 years old. Thirty years is typically the full life span of even high quality asphalt shingles. Therefore, we expect that a roof replacement should be included in the restoration.
