**Re: Residential Asbestos Building Inspection Report  
801 West High Street in Dowagiac, Michigan  
Heartland Project #5303-17-01**

Project Name: 801 West High Street Dowagiac, Cass County, Michigan

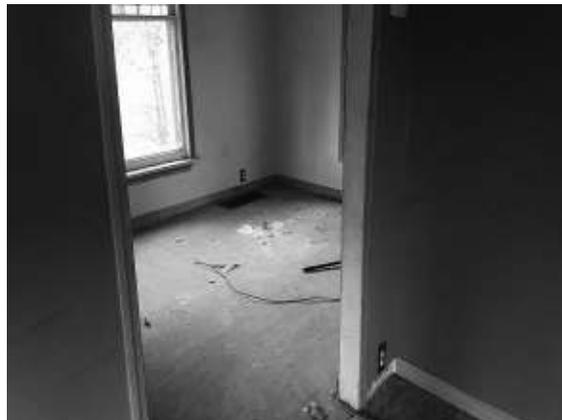
| <p style="text-align: center;"><b>Table 1</b><br/> <b>Summary of Sampled Building Materials</b><br/> <b>801 West High Street</b><br/> <b>Dowagiac, Michigan</b><br/> <b>September 5, 2017</b></p> | | | | | |
|---|---|---|--|---|---|
| Floor Tile/Mastic - 9” x 9” brown, 1 <sup>st</sup> Floor | No | I (Mastic Only) | <b>4% Chrysotile – Tile</b><br><b>2% Chrysotile – Mastic</b> | ~400 | FT – 1(A-C) |

| Photo #4: | View of 9"x9" ACM floor tile in first floor room (September 5, 2017) |

| CLIENT SAMPLE # | LAB SAMPLE # | SAMPLE IDENTIFICATION | ASBEST | CELL | NON FIB<br>NON<br>ACBM | FIB<br>NON<br>ACBM |
|---|---|---|---|---|---|---|
| FT-1A | 1711551 | BROWN FLOOR TILE | 4% C | --- | 96% | --- |
| FT-1A | 1711551A | BLACK MASTIC | 2% C | --- | 98% | --- |

It is the understanding of Heartland that the dwelling will either be renovated or demolished, meeting the definition of renovation and demolition, in accordance with the National Emission Standards for Hazardous Air Pollutant (NESHAP) for the State of Michigan. As ACMs in the form of resilient floor coverings and associated mastics encountered are non-friable, these flooring materials are recommended to be removed as part of demolition activities, provided the materials are not subject to sanding, grinding, abrading or any other mechanical operations which may damage the flooring materials and cause them to become friable. These materials can be disposed of as construction related demolition debris and will not require special abatement.

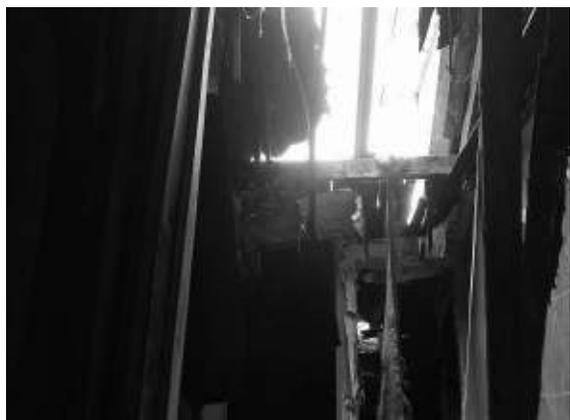
| Photo #5: | View of collapsed roof in back of home (September 5, 2017) |
