# **Cass County Land Bank Authority**

## **Request for Proposal General Contractor Home Rehabilitation**

1219 Barron Lake Rd – Niles, MI

## Structural Evaluation Report

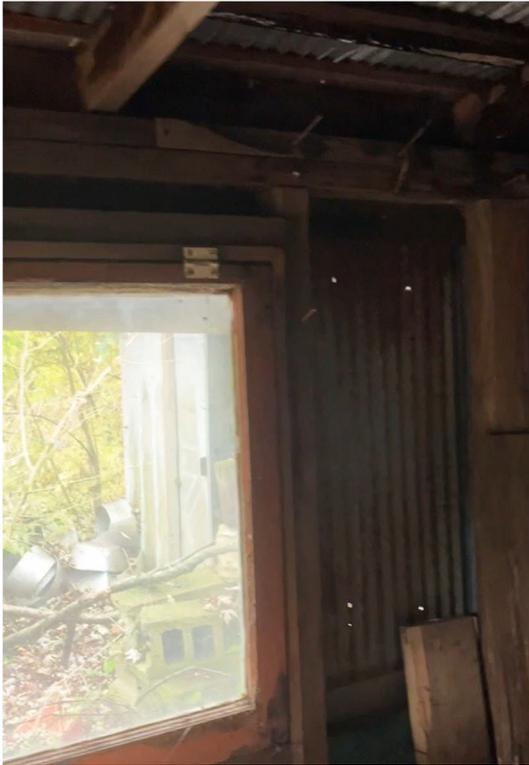
- Significant rot in both rafters and purlins.
- Roof bearing occurring on only (2) 2x4 members without adequate support.
- Separation between the wall and roof system at the southwest corner.

East side addition of garage. Picture shows double 2x4 top plate supporting roof rafters. And purlin roof black rot in 1x6 material.

This addition is in non-serviceable condition and provides minimal structural or functional value. Removal in its entirety is recommended.

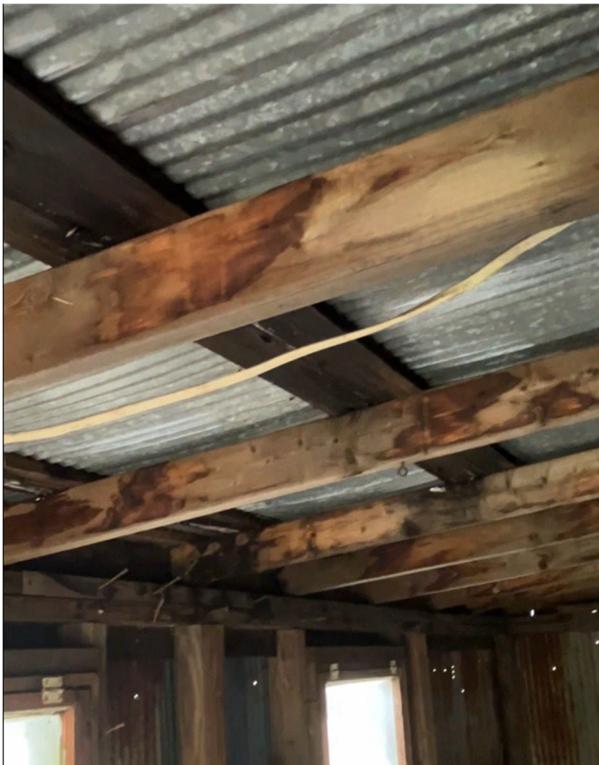
East side addition of garage. Picture shows 2x4 roof rafters and roof purlins. Roof purlins and rafters show signs of rot.

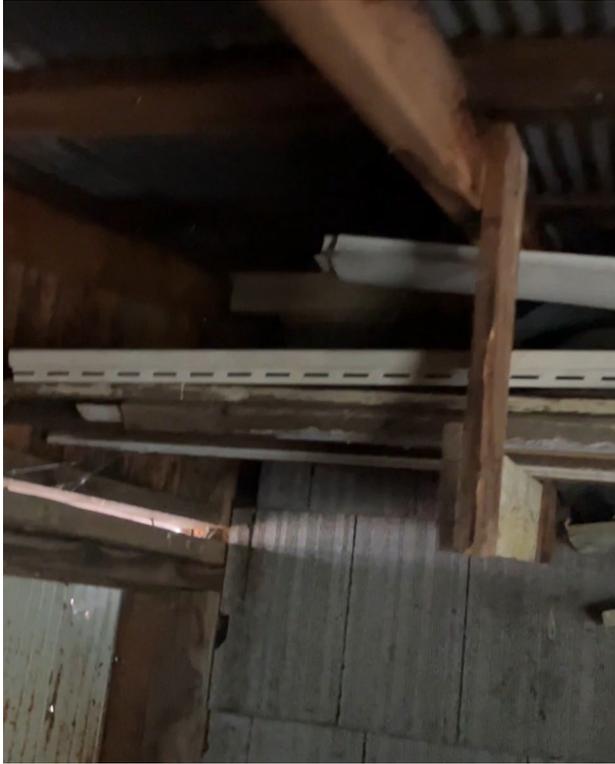
East side garage addition: picture shows gap between wall top plate and roof system. Separation of plate due to excessive movement.

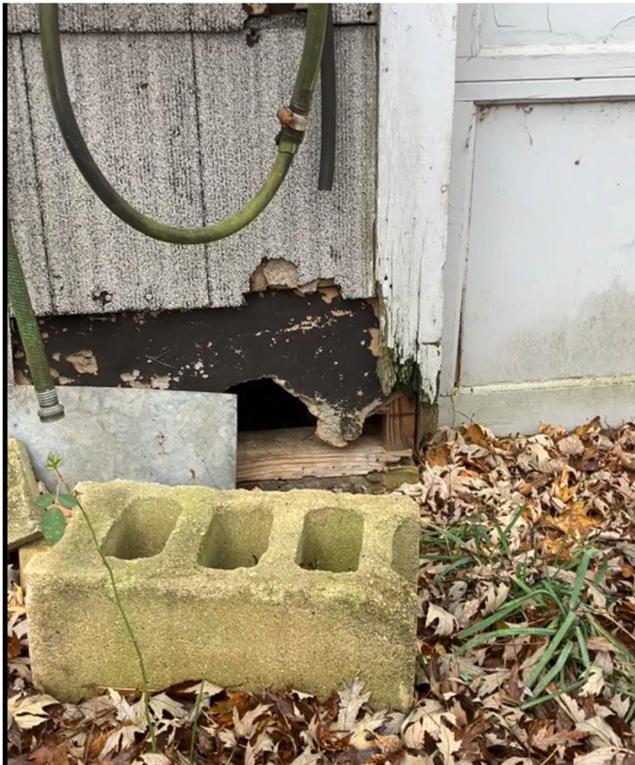
Exterior observations revealed rot in exposed rafter tails and deterioration of sheathing and trim near overhead doors.

Interior framing consists of 2×4 stud walls at 24" o.c. Most wall framing was in serviceable condition, though areas near exterior door openings showed water-related deterioration at sill plates and vertical studs. Headers were not installed at window and door openings. Ceiling rafters appear serviceable, though spans exceed current code limits.

North side exterior garage: picture shows damage to siding, fiber sheathing and sill plate between the garage doors.

- Install new structural headers at all new or existing window/door openings.
- Sister new 2×6 lumber to existing rafters where rafter tails are rotted, extending to support the roof overhang.
- Replace any rotted studs with new members matching existing dimensions.
- Replace rotted sill plates with preservative-treated lumber anchored to the foundation per code with ½"Ø wedge or epoxy anchors
- Remove existing damaged fiberboard sheathing and replace with 7/16" OSB, nailed per code.

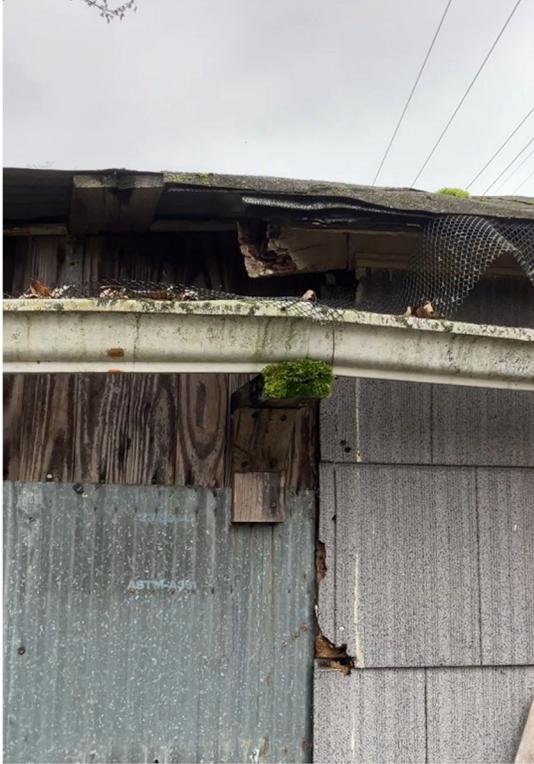
North side of garage between east addition and main garage: Photo shows damage to roof rafter tails.

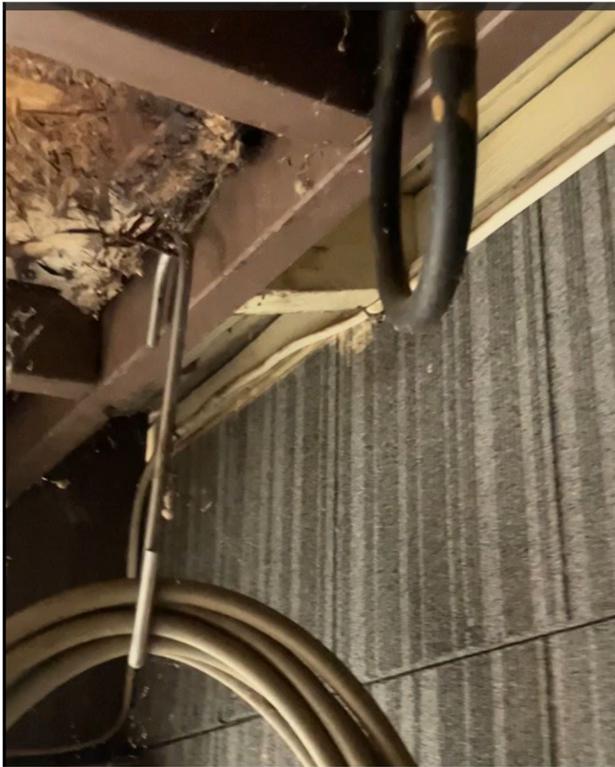
Water damage was noted near the roof intersection with the main garage, affecting both sheathing and rafter tails. Water damage at the lower roof area likely extends into the wall cavity.

West side addition of garage: photo shows roof ledger to rafter tails and water damage to sheathing.

- If a proper foundation is discovered during renovation, repair damaged roofing and wall materials using in-kind replacement and install a new ledger at the main garage wall with new rafters.
- If no foundation is present and the floor system is wood-on-grade, the addition has little repair value and should be removed completely.
- Due to extensive water damage in multiple areas of the garage, remove all roof material and install new roof sheathing and roofing to ensure the structure is watertight.

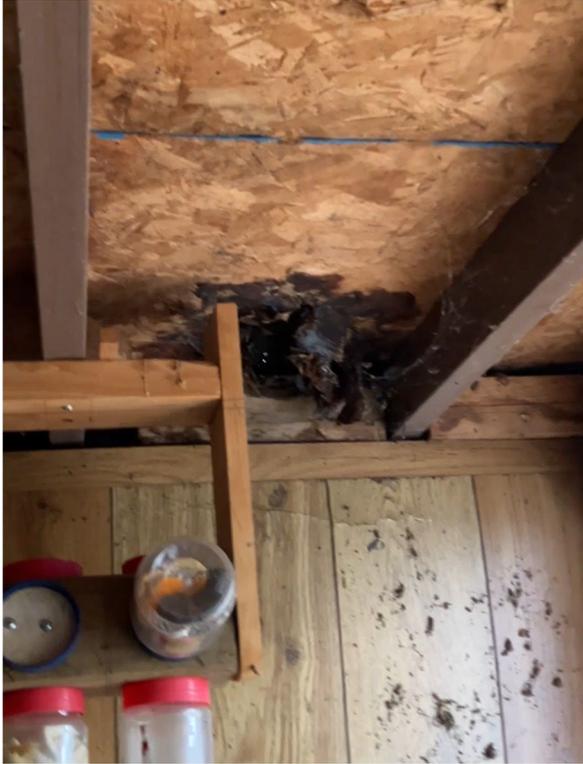
East side addition to garage: water damage through roof sheathing at lower bearing condition.

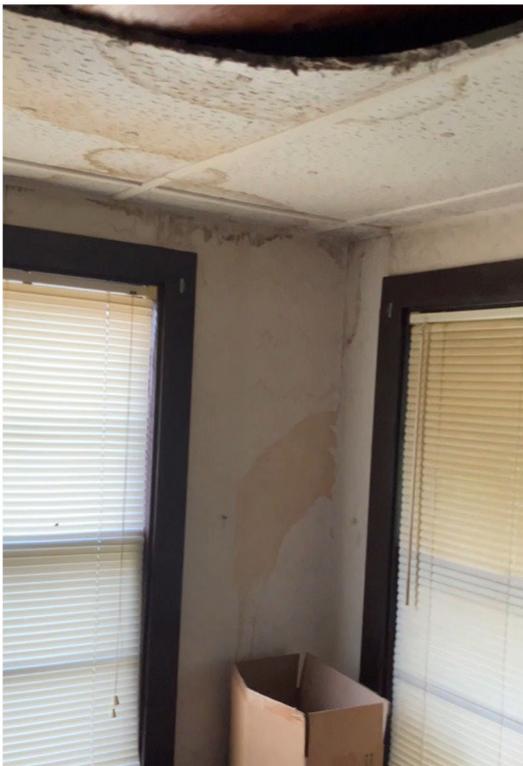
Interior ceiling damage revealed framing consisting of 2x4 roof rafters and ceiling joists at 24" o.c., bearing on the existing structure. Members appear serviceable, but water intrusion was significant.

West side addition to residence: photo shows water damage to ceiling and walls.

- Remove interior finishes to expose the full framing system.
- Inspect rafters, joists, and wall framing for rot or mold.

- Replace any degraded materials with matching in-kind lumber.

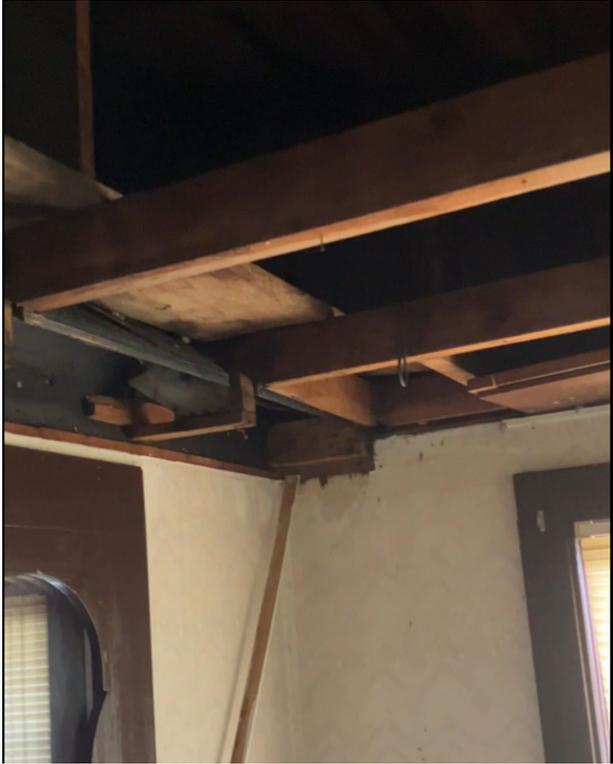
West side addition to residence: shows ceiling bearing condition on existing rafter tails. Ceiling was removed in this area due to extensive water damage.

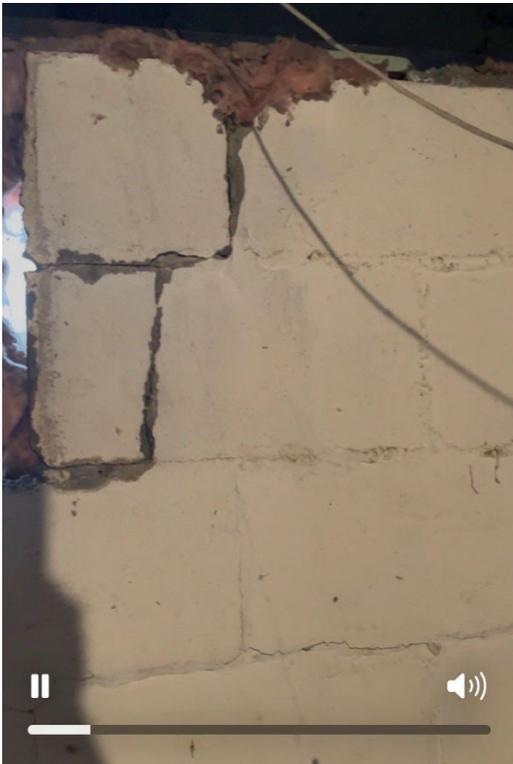
The CMU basement walls are in generally good condition. One horizontal crack was observed along the north wall within a mortar joint, allowing water infiltration. Crack may be due to excessive loading of adjacent driveway.

Basement of residence north side: photo shows cracking of cmu at north window along with horizontal crack below. Horizontal crack extends approximately 10 feet. Additional wall reinforcement should be added to prevent future cracking.

- Seal and repoint the cracked exterior mortar joint to stop water infiltration.
- Install an adjustable column beneath the beam south of the water heater to correct floor sag.
- Remove and replace all deteriorated sill plates with treated lumber.
- Remove and replace any framing exhibiting insect damage.
- Replace water-damaged subflooring at bathroom with new in-kind materials.
- Additional wall reinforcement should be provided at north end cmu wall to prevent future horizontal cracking due to vehicular loadings.

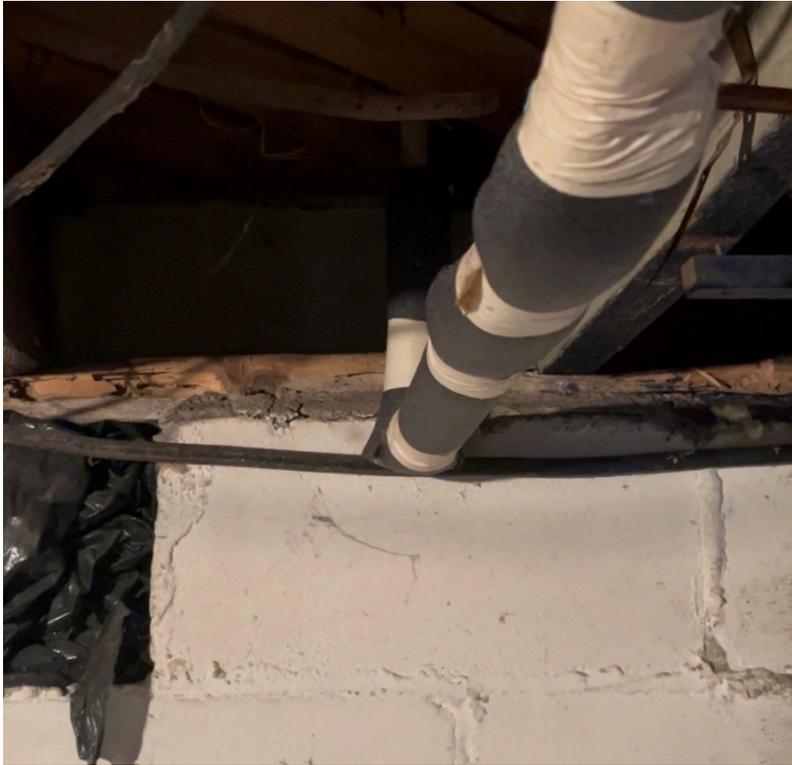
Floor framing above the basement was free from mold and severe decay. sagging was noted in a dropped beam supporting floor framing. Sill plates around the basement perimeter showed insect damage. Water damage to subflooring was also found beneath the main-level bathroom.

Basement of residence west side: photo depicts insect damage to wood sill plate. Damage was noted along the whole perimeter.

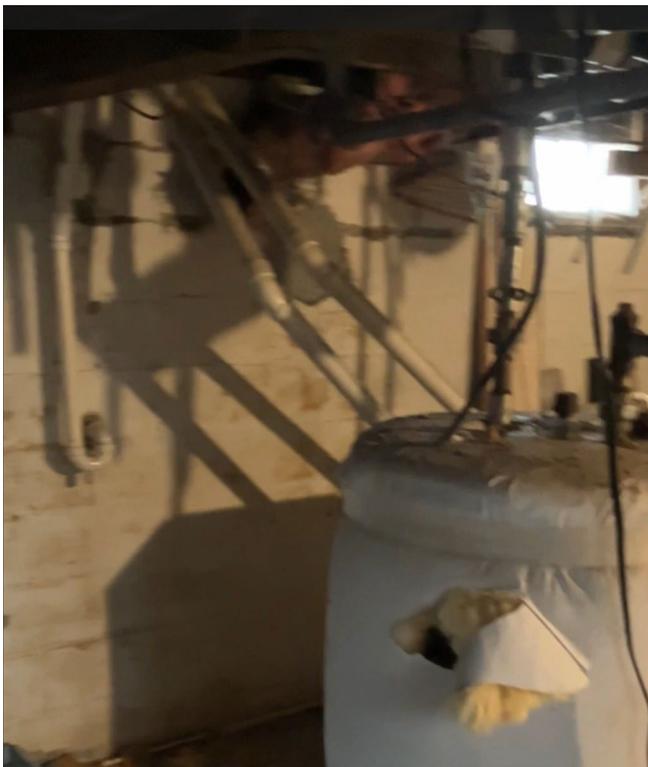
Basement of residence looking south: photo shows existing water heater with floor support beam above at the top left. Support beam was sagging with noticeable floor deflection on the main level.
