KELLER ENGINEERING, INC.

June 8, 2009

**RE: 1899 CASS COUNTY COURTHOUSE
ENGINEER'S PROJECT #0906-102**

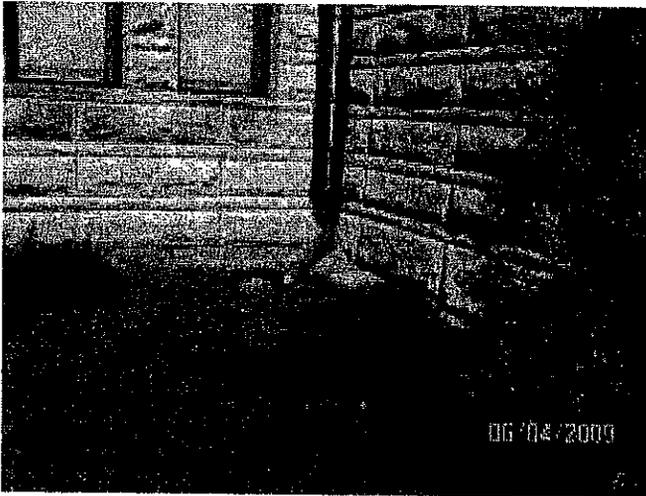
Since the building is situated on top of a hill, all of the water affecting its foundations comes from the roof and lawn areas on the property. We noted areas where the ground against the building is flat, or slopes toward the building. Also, many of the downspouts are piped into the ground where apparently they discharge water near the building.

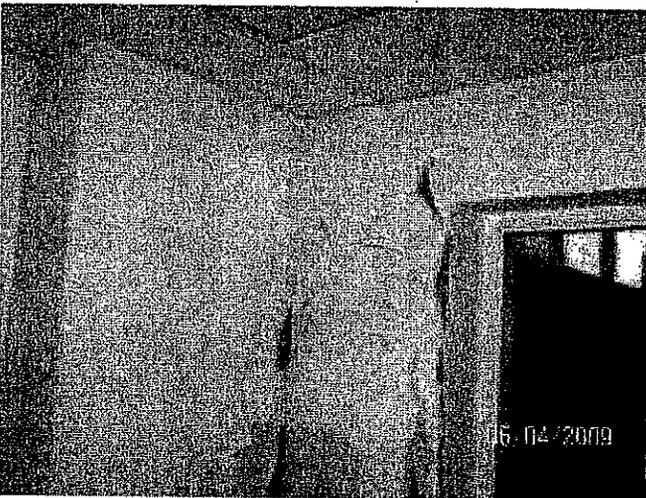
Many of the downspouts are also damaged from ice, which has split their seams allowing water to flow down the face of the building. The plaster inside the building near these leaking downspouts is damaged higher on the walls indicating that water is soaking into the walls from these damaged downspouts. We recommend that the gutters and downspouts be repaired and that the underground drainage system should be redone to get the water away from the building. From a building preservation stand point, it would be preferable if the roof drainage system could discharge to the east where it will flow away from the building to the

city's storm drainage system. A buried drain system could be installed around the perimeter of the building when the ground is put back following the tuck point and waterproofing operations along the west and south walls.

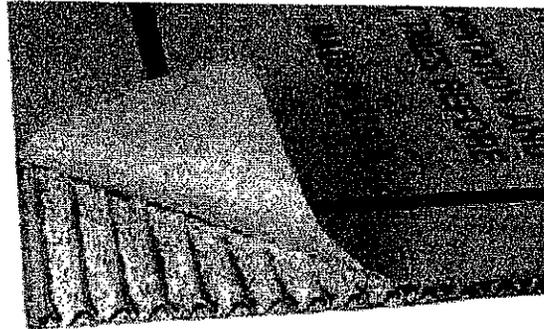
Both the Kingscott report and the Slatile proposal recommend installing bentonite waterproofing on the outside of the foundation walls. We concur with this recommendation. This is an excellent product for waterproofing basement walls; however, since the walls are built from stone, they are very rough and uneven. Although the bentonite will conform to the shape of the wall, we recommend that the walls should be tuck pointed on both the inside and outside to restore their strength, and to reduce the uneven exterior surface for the bentonite. This product comes in the form of cardboard panels with the bentonite in the cores of the cardboard. As the ground is backfilled over the product, it could compress and tear the cardboard unless the surface is relatively smooth. Therefore, in our opinion, the tuck pointing will help prepare the surface of the wall for the bentonite.
