# **KELLER ENGINEERING, INC.**

June 8, 2009

**RE: 1899 CASS COUNTY COURTHOUSE  
ENGINEER'S PROJECT #0906-102**

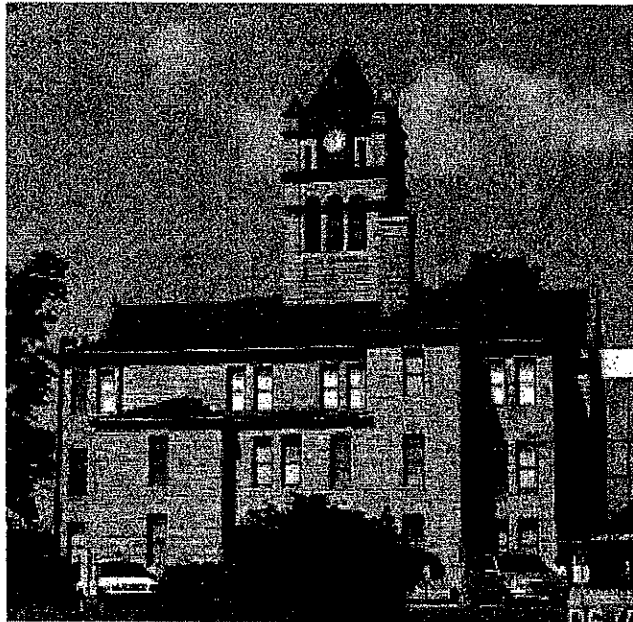
The original courthouse has been vacated with the addition of new space attached to the north side of the original building. The building has gone unheated or conditioned the last few years to save money. Cass County would like to preserve the building and find alternate uses for it.

The courthouse is a three story limestone structure with a stone foundation situated at the top of a hill in the center of Cassopolis. The ground around the building slopes up to the west where only the upper two floors are above grade.
